ENGINEERING OPINION
INVESTIGATION OF FOUNDATION PERFORMANCE
RESIDENCE AT 12345 ANYSTREET, HOUSTON, TX, 77062
Date of Inspection: May 25, 2012
Date of Report: May 26, 2012

SLAB SURFACE ELEVATIONS
 12345 Any Street, Houston, TX, 77062
 May 25, 2012

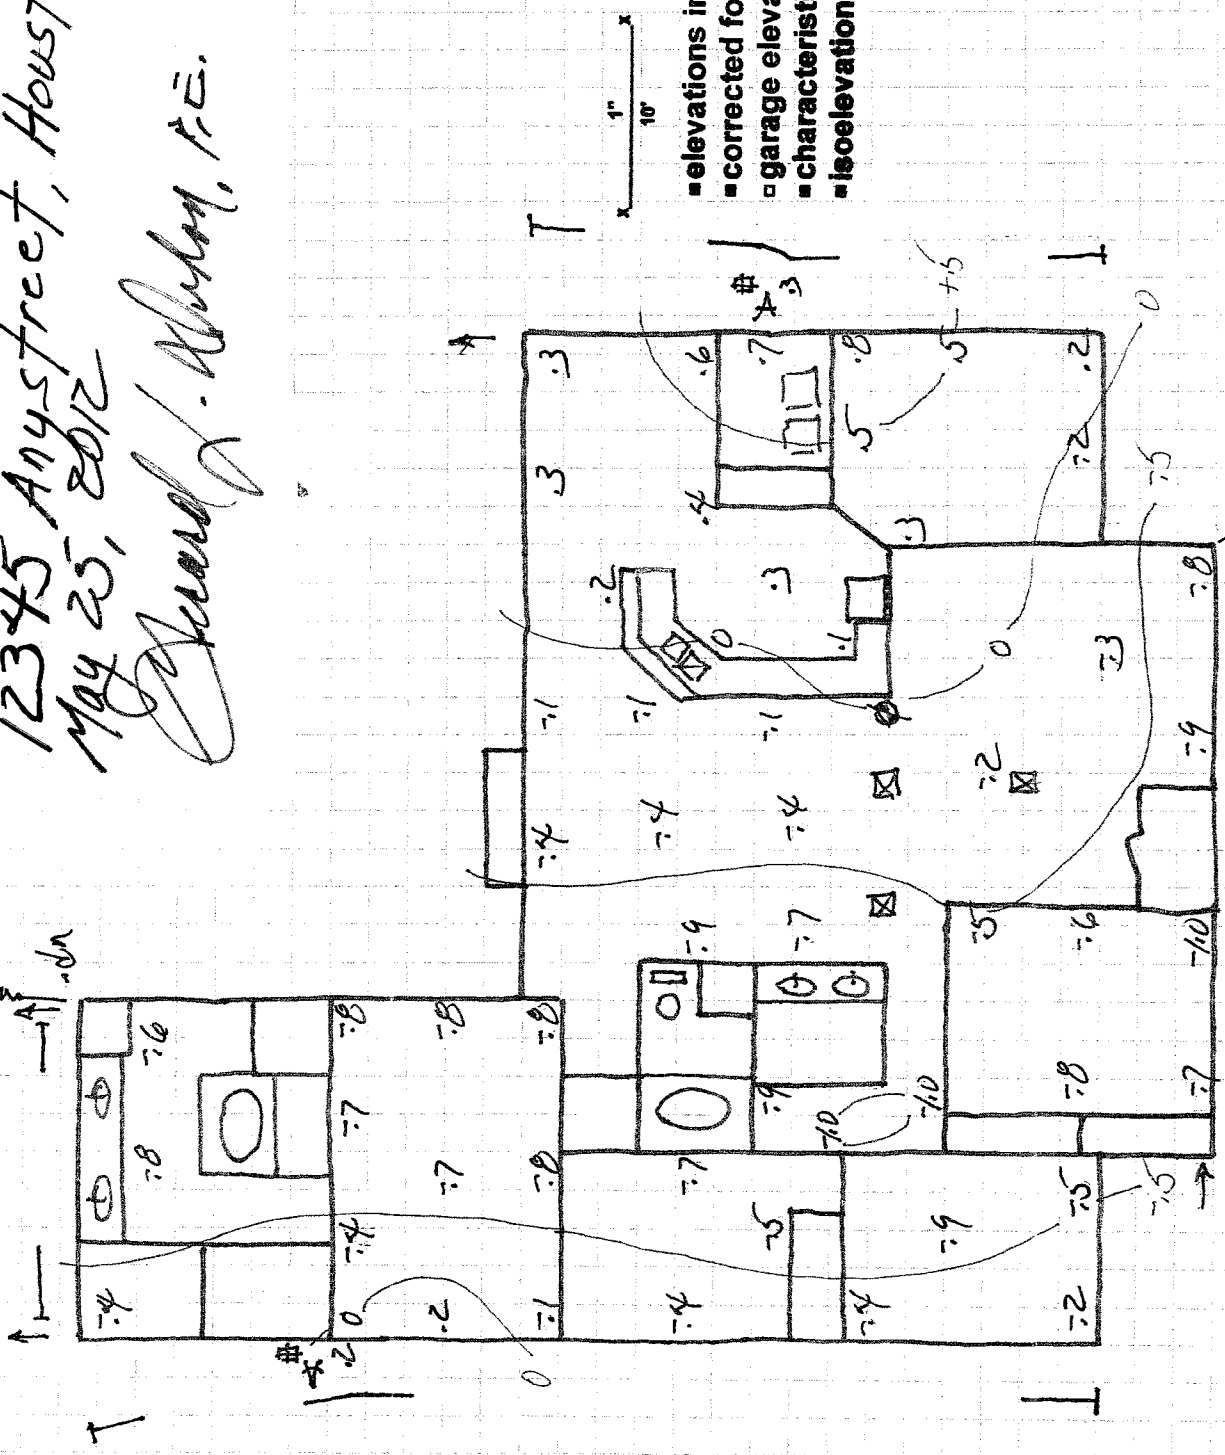
Inspection of the exterior found distress at the breezeway cover. This is usually due to relative movement between the garage and residence foundations. The elevation at the left side soffit of the garage was measured to have a 2 inch drop at the back. This area of the garage is within influential distance from a tree.

An elevation survey throughout the house was performed using a Technidea Zipline. The reference zero was the living area. The elevations have a range of 1.8 inches, highest at the utility room, lowest at the hallway. The foundation generally is flat and level, and rises towards the utility room. The elevation changes do not exceed the generally accepted criteria for foundation performance and repair of L/360 (1 inch in 15 feet).
